MEMBER ALERT

JUNE 2, 2015

RECENT GROUNDINGS IN ARGENTINA

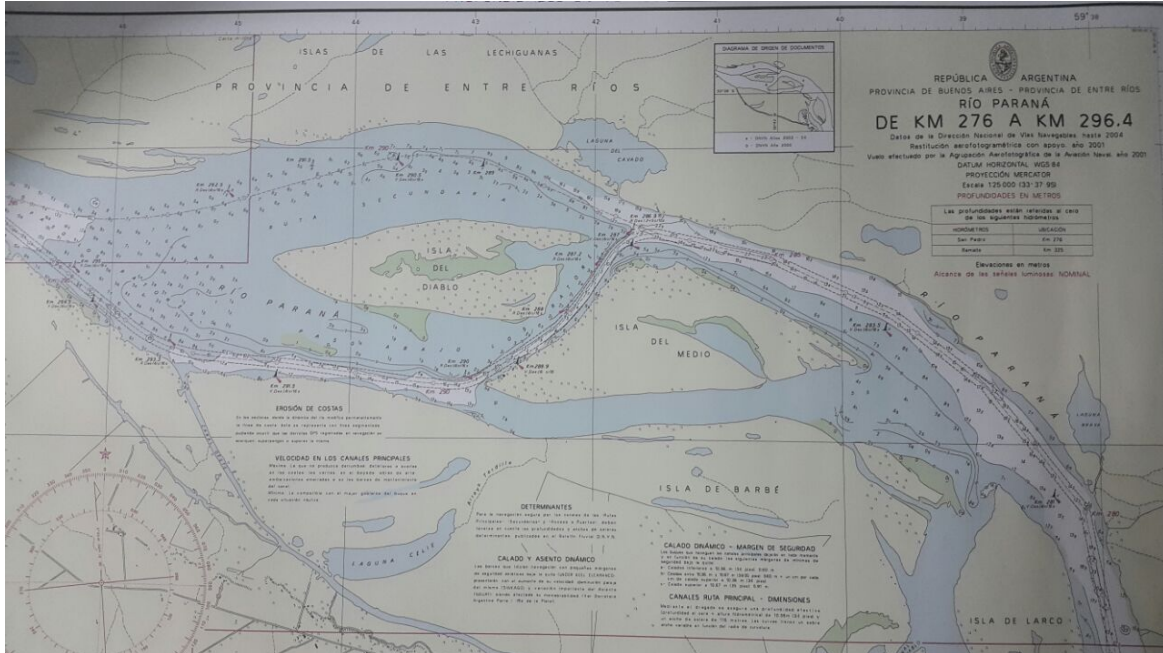
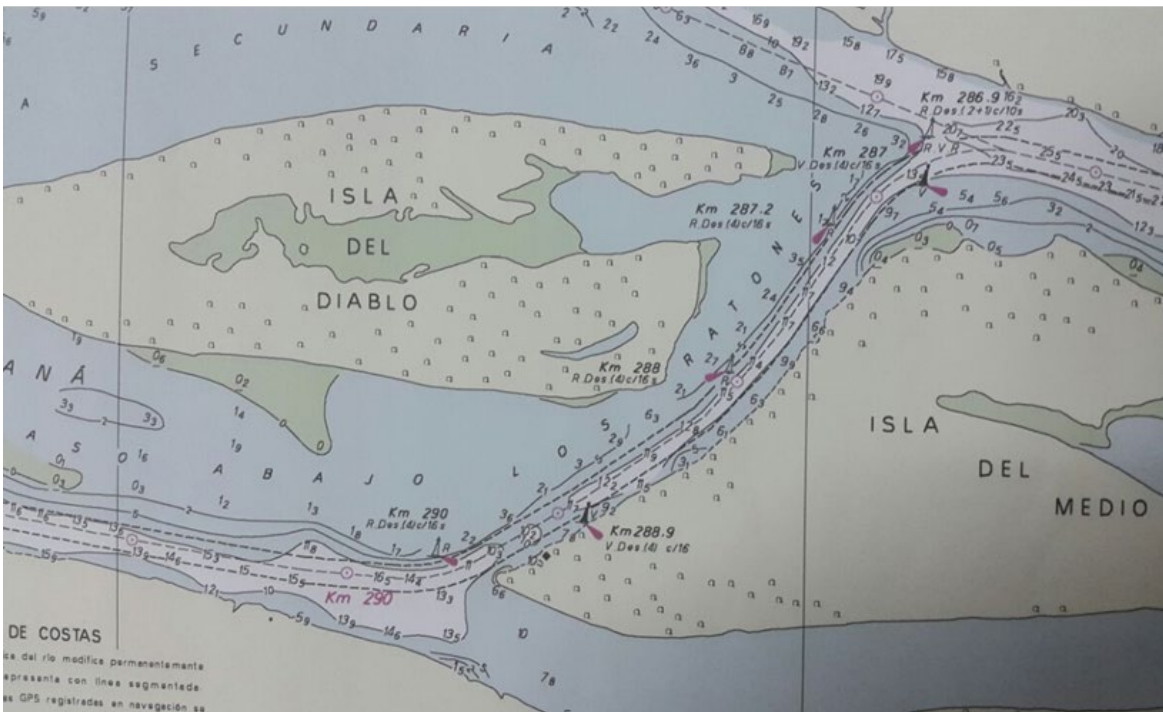
As will be noted from the attached photographs of the Argentine Chart H-103 vessels have to go through very sharp bends in the leg known as "Paso Abajo Los Ratones" where the river current always goes downstream at about 2.5 knots although this could vary depending on the level of the river. Therefore a combination of factors when negotiating these restricted waters could cause loss of control of a vessel with a consequent risk of grounding.

Although the authorities are reluctant to issue any official comments, they indicate that vessels navigating through the Paso Abajo Los Ratones in particular must remain within the dredged channel, identified on the attached chart extracts by dashed lines. Although the pilot has the conduct of navigation, the Master retains responsibility for monitoring the actions of the pilot and the ultimate safety of the ship rests with the Master.

Therefore it is recommended that a proper plan of navigation is discussed between the Master and the Pilot before commencing pilotage so that the Master is well aware beforehand of the crucial points on the river the vessel has to go through and the Pilot is well briefed on the characteristics and weaknesses of the vessel when navigating in this area.

The Master should also monitor the electronic charts used by most pilots, on which the ship's position within the dredged channel is generally shown. On the other hand the vessel has always to comply with the 2 foot under keel clearance for safe passage taking into account the permissible sailing draft which is informed by Coast Guard on daily basis in accordance with information provided by the Department of Waterways and ports.
