An Engineer Falls

Description

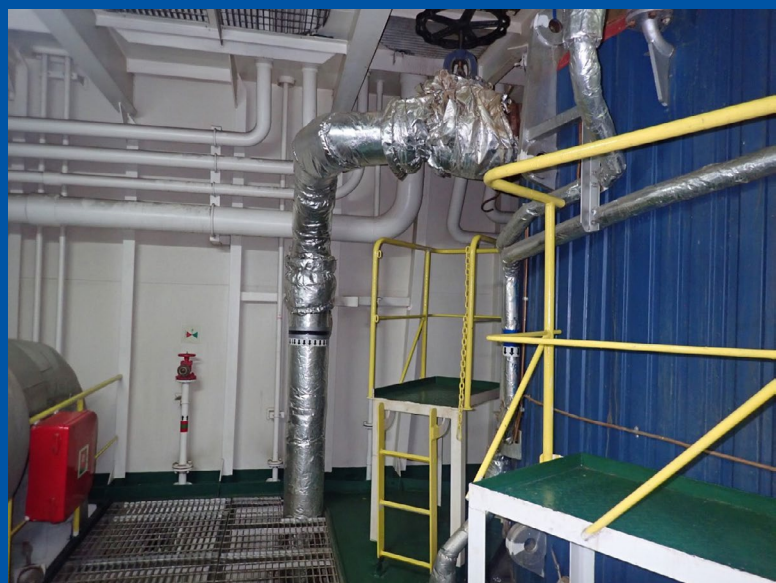
The work went according to plan and the new gasket was installed. However, they had difficulty correctly aligning the valve bonnet with the valve body just using one chain fall. So, the Third Engineer climbed onto the first rung of the railing to manually guide the valve bonnet into place. As he pushed the hanging valve bonnet into position, he was giving directions to the engineer working the chain fall. At the last second, the Third Engineer had to pull his hand back to keep his fingers from getting caught under the valve bonnet. When he did so, he lost his balance and his foot slipped off the railing. He landed hard on the deck and injured his back.

The Third Engineer injured his back when he fell. He was treated at the hospital and eventually sent home to recuperate. He was unable to work for almost six months.

- ★ What else could have been discussed at the toolbox meeting? Did the toolbox meeting address all safety concerns associated with upcoming work, or just the most serious safety concerns?
- ★ When the Third Engineer stepped up onto the railing, should someone have identified and said something about the potential safety hazard or risk? Do you have a system in place that allows for anyone to call a stop to the work when there is a safety concern?
- ★ What could have been done instead of someone trying to stand on the railing?
