BANK SUCTION GETS UGLY

BANK SUCTION DAMAGE

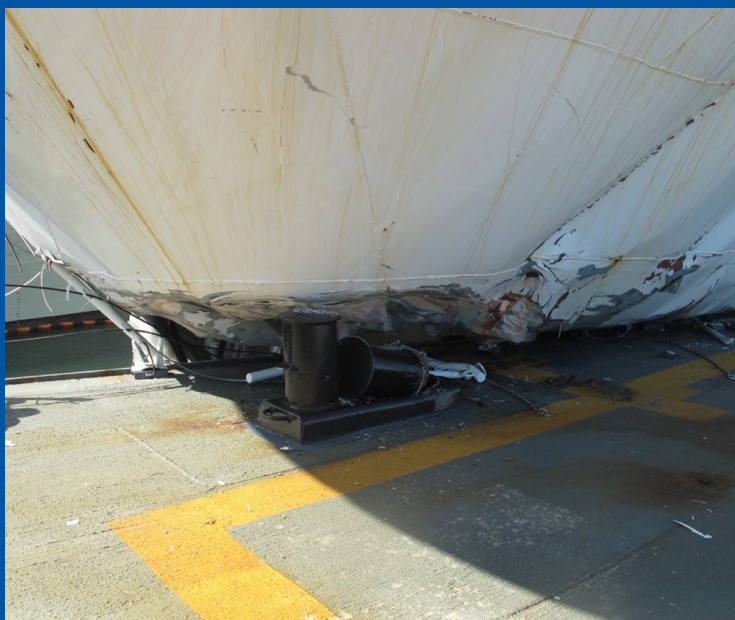
While negotiating a bend in the river, the vessel experienced bank suction, or “bank effect.” As a result, the vessel did not respond to its rudder as expected. The pilot was trying to get the vessel to turn to port and travel around the bend in the river. Instead, the vessel continued straight, quickly crossed the river, and struck a pier. The pilot had ordered the anchor dropped, but there wasn’t enough time and space for the anchor to arrest the vessel’s motion or change the vessel’s heading.

When the vessel struck the pier, the bulbous bow penetrated beneath the pier, damaging several support pilings. The damage to the bulbous bow and forepeak tank on the vessel cost \$125,000 to repair. The third-party claim for damage to the pier structure, pier face, fender system, and bollard exceeded \$245,000.

- ★ The Master-pilot exchange should have included a discussion of the transit plan for the vessel and identified concerns about hydrodynamics along the river including bank suction and bank bounce effect. The Master and pilot should have agreed on a plan to avoid those effects while also closely monitoring the vessel's movement in areas where those effects might be expected.

- ★ The voyage plan should have laid out the vessel's course and position for the entire river transit and should have taken into account all areas where bank suction or bank cushion effect could be expected.

- ★ Good Bridge Resource Management (BRM) includes close tracking of the vessel's transit and the vessel's responsiveness to rudder and steering commands. In this incident, better BRM would have quickly identified that the vessel's track was closer to the bank than planned, which increased the risk of bank suction. Good BRM would have more quickly identified the vessel's failure to respond to the port rudder command as expected.
