## ECDIS Over-Reliance and Poor Bridge Resource Management (BRM) Lead to a Vessel Grounding

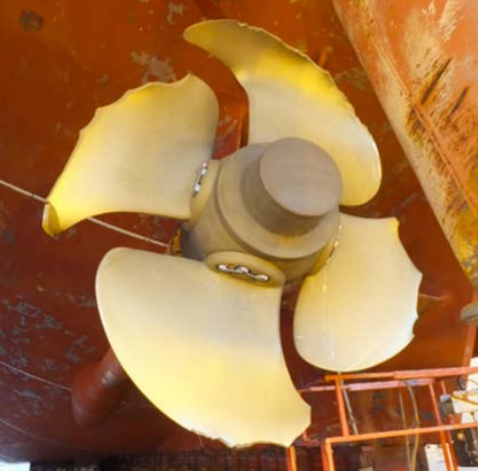
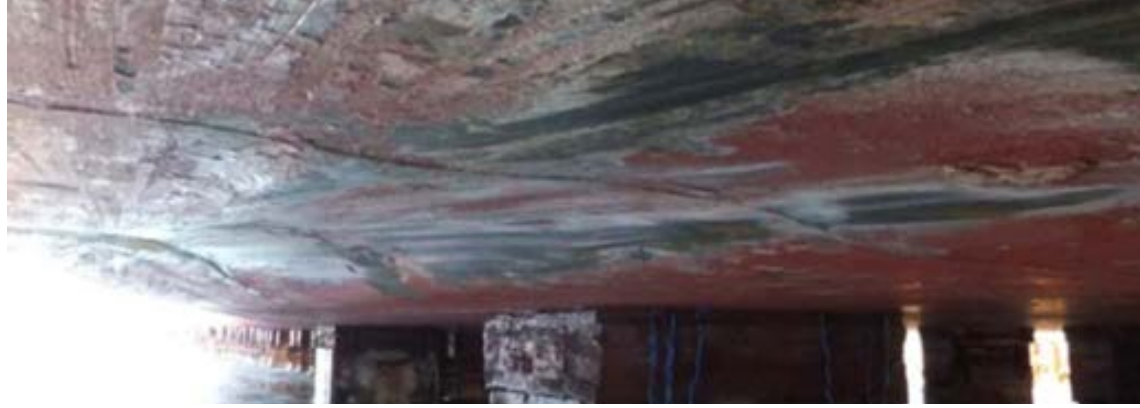
The port propeller was seriously damaged and the port shaft was bent. The rudder stock was displaced and the hull and internal structure was damaged on the port side from midships all the way aft. The vessel was out of service for three months for extensive repairs that exceeded \$1 million in cost.

Damage to propeller and bottom of the hull due to grounding
