GOOD CATCH from The American Club

Engine Room Egress During a Fire

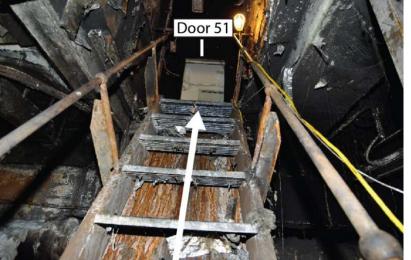
Ladder and door through which the Chief Officer and 3 engineers escaped.

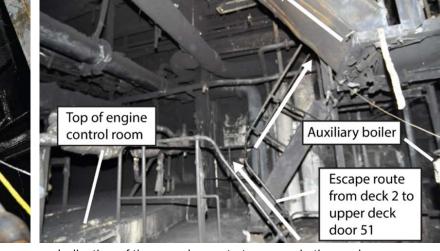
Indication of the complex route to egress in the engine room.

- Don't become complacent regarding fire alarms, even if recent fire alarm activations were caused by heat or malfunction.
- **★** Treat each alarm as if it is a real fire. Trust the alarm system.
- ★ Follow the SMS fire safety procedures each time. Follow them during every fire drill and follow them when the alarms sound. Do not deviate from them or disregard them in a real emergency. The delays in getting everyone to their designated muster and fire stations could allow the fire to grow significantly.
- ★ When the general alarm is sounded, muster at the designated stations as required. Those pre-determined muster stations are where the emergency equipment is located and are the best places from where to respond to the emergency.
- ★ Know how to egress from every location on each level in the engine room and practice egress.
