GOOD CATCH from The American Club

Engine Room Flooding Averted!

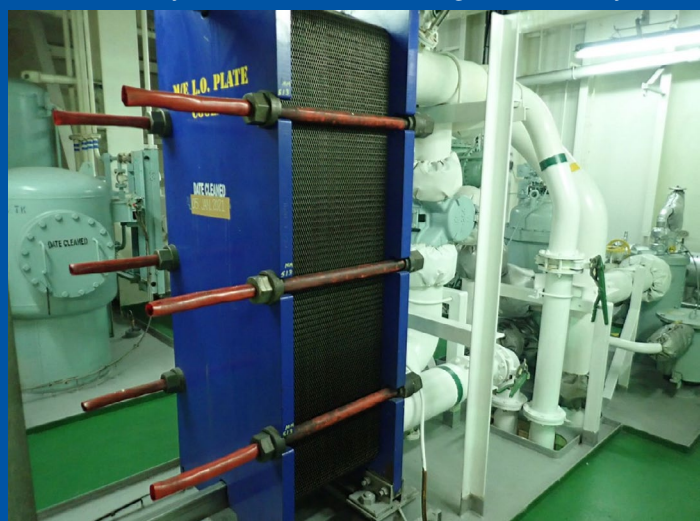
Had the valve been opened while the plate cooler was still partially disassembled, salt water would have poured into the engine room. If the flooding was quickly recognized and the valve closed, the result would have just been the addition of several hundred gallons of saltwater into the bilges. However, if not quickly corrected, a large volume of saltwater flooding into the engine room could easily have overflowed the bilges and caused damage to the main engine, auxiliary machinery, and electrical systems in the engine room. Repairing damage from saltwater flooding in the engine room can be very expensive and time-consuming.

- ★ The engineers conducting the maintenance on the lube oil plate cooler should have followed the Lock Out/ Tag Out procedures. They should have labeled all of the valves they closed and labeled and secured power to the controller for the associated saltwater and lube oil pumps. They also should have posted a notice of their work in the engine control room.
