## Extreme Bollard Pull

American Steamship Owners Mutual Protection & Indemnity Association, Inc.

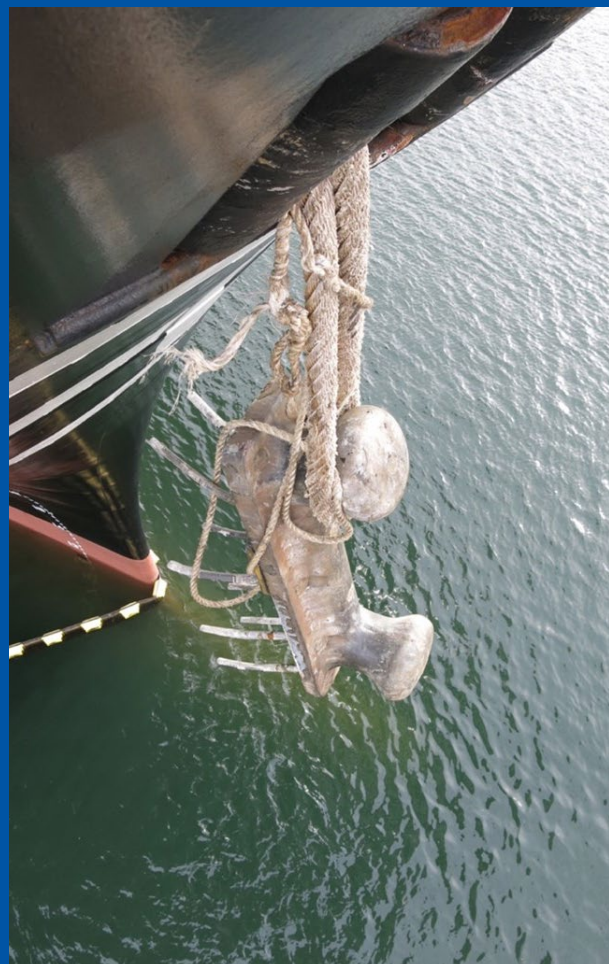
**A large container vessel had just begun cargo operations.** Approximately 2 hours later, the bollard holding the bow lines was pulled out of the dock. The bow of the vessel swung outboard slightly, and the stern swung into the dock. Fortunately, the forward spring lines held and stopped the swing. The stern of the vessel contacted

Upon investigation, the four bow lines from the vessel had all been attached to the same bollard, the one that failed. The two forward spring lines were both attached to a different bollard. The two aft spring lines were both attached to yet another bollard. The four stern lines were paired to two different bollards astern of the vessel.

Inspection of the bollard indicated that some of the bolts attaching the bollard to the dock had sheared and some of the bolts were pulled out of the mounting intact. Each of the four bow lines was on a self-tensioning mooring winch. The combined load of the four winches together exceeded the bollard's rated load. The Master indicated that he did not know the rated load of the bollard and had just assumed it was adequate since the pilot and line handlers placed all four bow lines on it.

The repair to the bollard exceeded \$37,000. There was no damage to the vessel.

- ★ Do not overload bollards with multiple mooring lines. If the load capacities of the bollards are not known, the Master should contact the port or facility owner via the agent to obtain that information and adjust the mooring plan accordingly so the bollards will not be overloaded.
- ★ When deviating from a normal mooring practice such as only putting two mooring lines on a bollard, the specific risk of overloading a bollard should be evaluated based on the capacity of the bollard, the number of mooring lines that will be placed on that bollard, and the settings on the self-tensioning winches.
- ★ If cranes or other dockside equipment block access to bollards that would normally be used, or if bollards that would normally be used are already being used by other vessels, the options should be discussed, and the risks should be identified and assessed before proceeding.
