# GOOD CATCH from The American Club

## Footing Failure

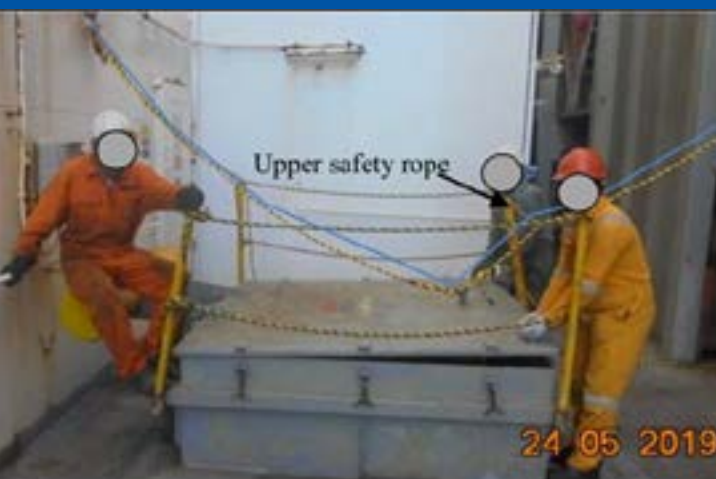
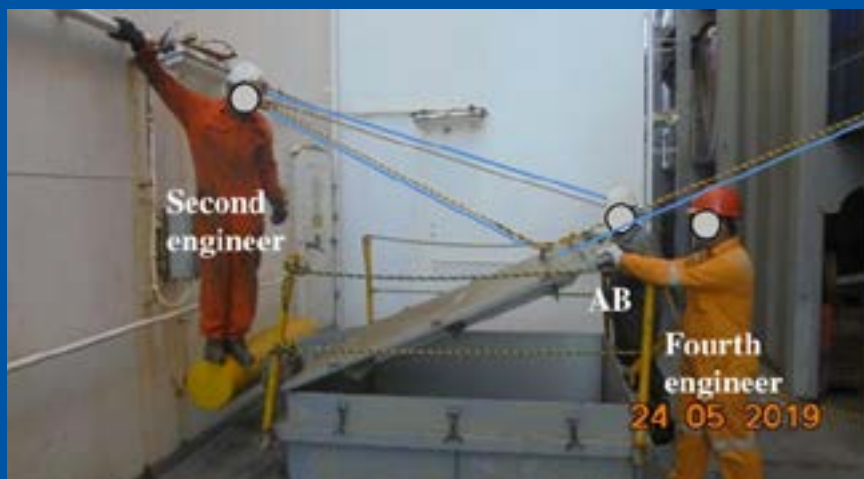
As seen in the figures below, the hatch to the engine room was large and mounted on a raised coaming and fitted with a counterweight to make it easier to open. Once it was open, the hatch could be secured in the upright position using a pin. The hatch was reported to be in good operating condition and well maintained. Stanchions with ropes surrounded the hatch to prevent someone from falling in when the hatch was open.

To help get the hatch open, the 2nd Engineer sat on the counterweight to increase its effect. The hatch still did not open so he then stood on top of the counterweight hoping it would then open with his full weight applied. The hatch then opened but as a result, the 2nd Engineer lost his footing and fell with his left leg sliding between the counterweight and the hatch coaming breaking a bone in his lower leg.

At the time of the injury, the 2nd Engineer was wearing a boiler suit, hardhat, gloves and safety shoes. The shoes were in good condition with good tread but were ineffective on the cylindrical smooth surface of the counterweight.

- ★ The vessel's crew knew that the counterweight was insufficient by itself to open the hatch and would require the assistance of several crew members. It was also clear to the crew that opening the hatch would have to involve several personnel and rigging of safety ropes. These issues alone should have triggered those responsible and those engaged in the operation to consider a risk assessment prior to the commencement of the operation.

- ★ Such a risk assessment should consider additional safer options that might have been available. For example, the same crane being used to lift the spare parts and lower them into the engine room could have been used to lift the hatch first. A block and tackle or chain fall could also have been used to help lift the hatch until the effect of the counterweight took over.

- ★ Adding physical body weight to the counterweight by sitting or standing on it seemed a simple idea but was found to be a poor decision as well as an unsafe one. The 2nd Engineer failed to assess the risks to his own safety.

- ★ Further, any of the other crewmembers involved in the operation could have and should have stopped the operation for safety reasons when they saw the 2nd Engineer sit and eventually stand on the counterweight. The counterweight had not been designed for either sitting or standing for any reason.
