GOOD CATCH from The American Club

Who Needs a Hot Work Permit?

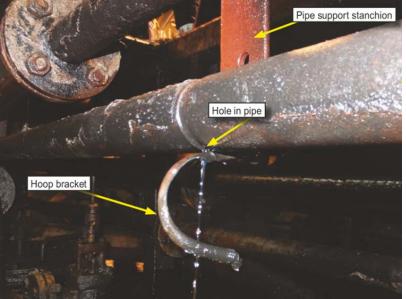
A vessel was underway when the Third Engineer on watch smelled diesel fuel while making a round in the engine room. He discovered that a fuel pipe was leaking under a bracket that secured the fuel pipe to a support stanchion. It appeared that the bracket had vibrated against the pipe and had worn a small hole in the fuel pipe. Diesel fuel was dripping at a steady rate.

While setting up his tools and accessing the leak, diesel fuel soaked the left pant leg of his coveralls and had formed a small puddle on the deckplate under the leak. When he started cutting the bracket with the angle grinder, the sparks from the angle grinder caught both his pant leg and the puddle on fire.

- **★** The Hot Work Permit process exists for the safety of the crew and the vessel. It is not optional and should always be used whenever any hot work is anticipated.
- ★ Grinding is hot work as is every other activity that produces sparks or generates heat.
- ★ Fuel leaks should be treated as potentially serious problems. Fuel leak repair decisions should always involve the Chief Engineer.

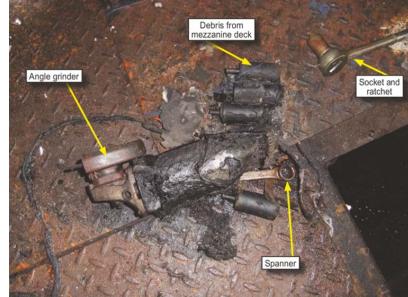
The damage to the engine room was limited to the immediate vicinity of where the fire started. Several piping systems and electrical cable runs had to be replaced. The vessel was out of service for approximately 30 days and repairs cost over \$250,000.
