GOOD CATCH from The American Club

Man Overboard: Questionable Risk Assessment, Questionable Safety Gear

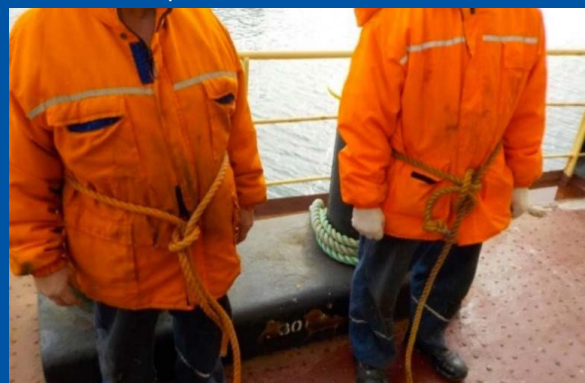
On this vessel, the mooring lines were secured on the poop deck because no enclosed storage was available. Numerous mooring lines were found displaced and tangled making efforts to lift them up to the first deck unsuccessful. The Chief Officer then went down to the poop deck to assist from there. After some limited success, the Chief Officer asked the Bosun to get additional assistance in the form of 2 ABs and a deck trainee. Together they were able to secure two of the mooring lines to the railing on the starboard side. Additional crewmembers arrived to assist and at one point all of them were working from the deck above except for the Chief Officer and the deck trainee who had remained on the poop deck finishing securing the mooring lines. Just as they finished, two large waves in quick succession washed over the poop deck taking the Chief Officer and the deck trainee overboard.

The investigation identified some inconsistencies about the incident, but it was apparent that both the Chief Officer and deck trainee had ropes tied around their waists as simulated in the picture. It was unclear whether the other ends of the ropes tied around their respective waists were secured properly to the ship or whether the two mariners were tied to each other at that point.

★ **Safety gear.** Appropriate safety gear is there to be used. In this instance, harnesses should have been worn by each mariner on the poop deck and adequately secured on the first deck (the manned deck above) where they could have been tended properly until the Chief Officer and deck trainee were safely and completely out of harm's way.

Additionally, lifejackets and exposure suits should have been used to keep the mariners afloat and buy them time until the ship could turn and attempt a rescue should they be washed overboard. Since the water temperatures were dangerously cold and the sea conditions so rough, the benefit of additional lifesaving protection should have been judged as outweighing the inconvenience of the bulk of that additional safety gear.
