GOOD CATCH from The American Club

Voyage Planning Problems Lead to Grounding and Loss of Ship

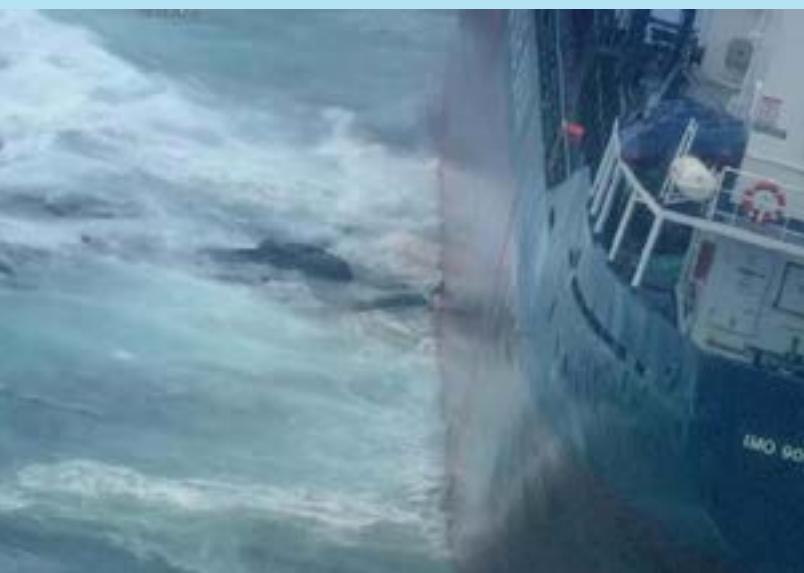
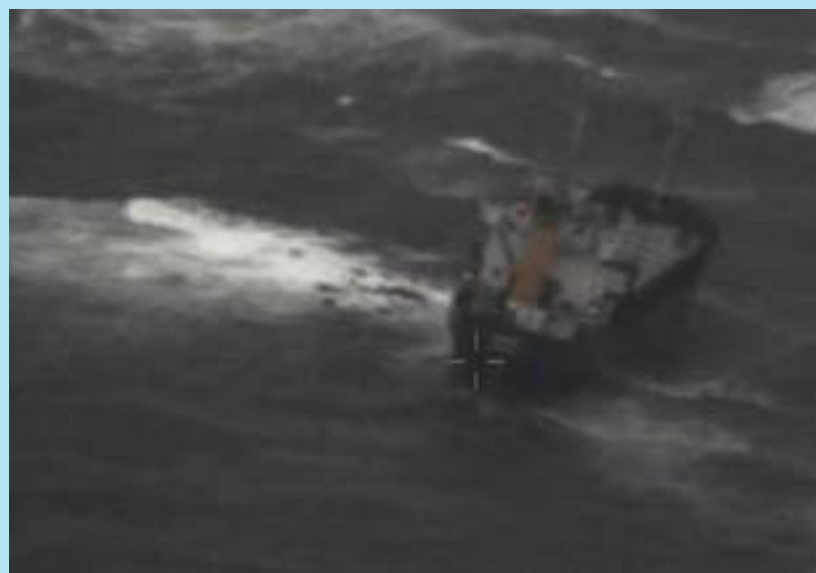
Due to worsening weather and following seas, the Master altered the voyage plan in the ECDIS after the vessel was underway. He did that by changing the track lines but again did not use an appropriate large scale chart. Inadvertently, he routed the vessel directly over a charted shoal that was clearly marked on the large-scale chart, but not visible on the small scale chart that was used. Since he modified his own initial voyage plan, there was no second set of eyes that reviewed it for any errors or issues.

When the vessel struck the shoal, numerous empty ballast water tanks were holed and quickly began flooding. With a damaged ship that was hard aground in bad weather and at risk of sinking, the Master decided to abandon the vessel and the entire crew had to be rescued by helicopter.

The damage to the vessel was so extensive that the ship was declared a constructive total loss.

- ★ Good voyage planning requires attention to detail and use of large scale charts, whether paper or electronic.
- ★ A key part of voyage planning is an independent review, no matter who prepares it, to catch any errors that could jeopardize the vessel's safety if left undetected.
- ★ Changes to a voyage plan deserve the same required oversight as the initial voyage plan and that oversight can be critically important.
- ★ Treat the inherent ECDIS alarms and features as critical safety nets instead of silencing or deactivating them.
