## Fatigue a Factor In Towing Vessel Grounding

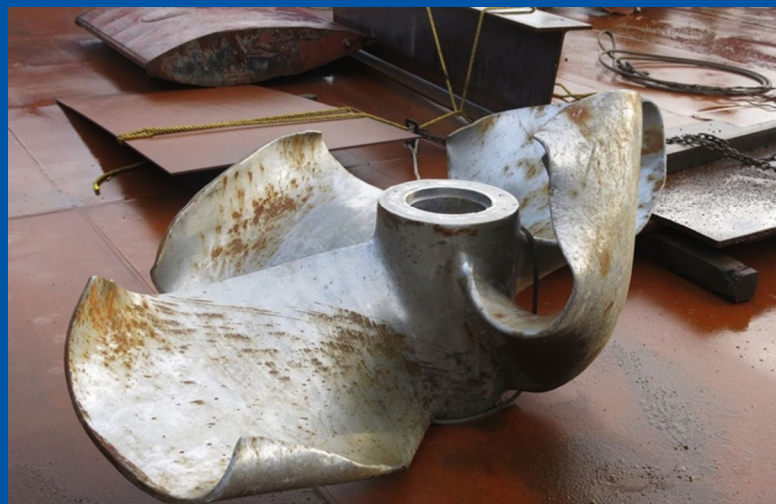
At approximately 1:25 am, the towing vessel ran aground on the shoal. The grounding caused both main engines to shut down.

**Both ducted propellers were heavily damaged. The starboard duct was torn off and the propeller and shaft were bent beyond repair. The port duct was heavily damaged as was the propeller. The towing vessel was out of operation for 10 weeks until a drydock was available, new propellers were purchased, new ducts were fabricated, and 2 new propeller shafts were fitted. The repair cost was in excess of \$950,000.**

- ★ Except in emergencies, the requirements for adequate rest should never be ignored for the sake of operations.
- ★ The record of hours worked should be honestly filled out and maintained. Recordkeeping associated with work and rest should be made part of the culture onboard each vessel and part of the vessel's safety program.
- ★ Mariners on watch who are having difficulty staying awake should recognize that the safety of the crew, the vessel and the cargo is at risk. They should either take direct action to maintain their alertness (stand up, move around, call a deckhand to come to the bridge, have a cup of coffee) or call the Master and ask for assistance.
- ★ ECDIS alarms are valuable tools that should be fully used and correctly set.
