## Mooring Line Failure

### Description

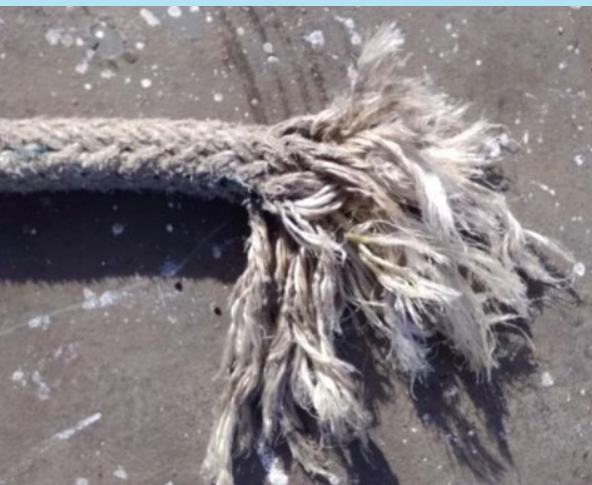
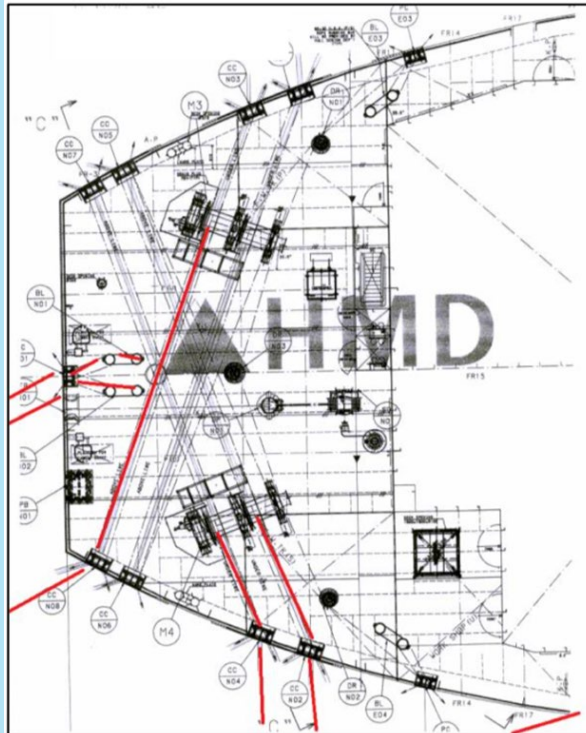
Intended mooring configuration showing three stern lines.

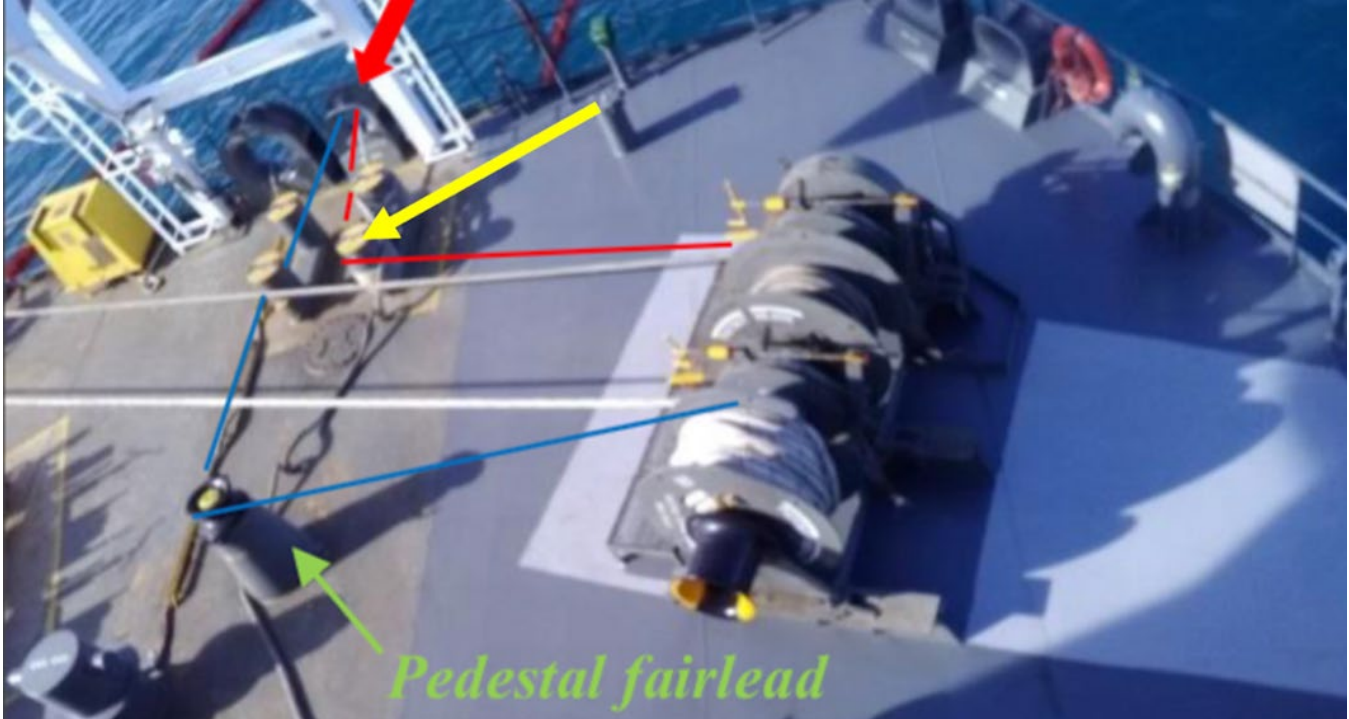
In the process of mooring, the load on the three stern lines was unevenly distributed with most of the strain on the mooring line using the stern bitt as a fairlead. When the Master directed the aft mooring station to heave on the stern mooring lines to arrest the motion of the tanker, the mooring line with the majority of the strain parted at the point it passed across the stern bitt.

The investigation also determined it was highly likely that the stresses induced in the mooring line that parted were due to the external friction from the mooring line passing around the stern bitt. Furthermore, the mooring configuration used by the Third Officer was not supported by the vessel's mooring design as mooring lines from the port side mooring winch were designed to be led through the starboard quarter fairlead not the center fairlead.

The unusual mooring configuration also contributed to the uneven strain on the three mooring lines. Lastly, the investigation determined it was very likely there was a breakdown in communication during the Master-Pilot exchange whereby the Third Officer did not fully understand the Master's intended mooring configuration.

Actual mooring configuration attempted with two mooring lines from the port side mooring winch through the stern center fairlead (blue and red lines) and a third loose mooring line secured at the stern bitt and also passing through the center fairlead (red arrow). The yellow arrow is the point where the mooring line failed.

- ★ It is critically important for the Master, Pilot and deck officers to have a common understanding of the intended mooring configuration.
- ★ The risks associated with any uncommon mooring configuration should be specifically evaluated regarding the potential to put excessive stresses on mooring lines as they pass around and through fairleads. In this instance, a risk assessment should have been conducted in advance.
- ★ Any uncommon mooring configurations should also be assessed and evaluated to ensure they are consistent with the design of the mooring winches and fairleads.
- ★ All mooring lines should be frequently inspected to look for signs of abrasion, broken fibers, worn spots and other damage. They should also be turned end-for-end at specified intervals and be replaced after a specified lifespan.
