MEMBER ALERT

MARCH 9, 2020

AMERICAN PILOTS' ASSOCIATION REQUEST - DANGEROUS TRAPDOORS

A Request from the American Pilots' Association to State Pilotage Authorities Regarding Pilot Safety

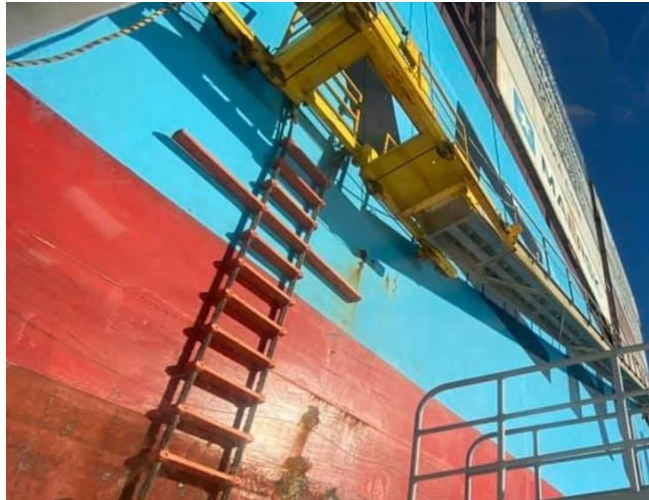
Example of trapdoor arrangement with ladder hanging from bottom of platform

This trapdoor arrangement is currently found on a number of ships with accommodation ladder-pilot ladder combinations, despite the facts that it has long been considered by pilots to be unsafe and that the IMO has recognized that it is unsafe by taking steps to eliminate it. Since at least 1979, IMO guidelines have recommended that pilot ladders used with a trapdoor extend to the height of the platform's handrail. The purpose of that recommended practice is to bring the ladder steps up to a level from which the pilot can step across to the platform rather than pull himself or herself up to it.

To address the pilot ladder-platform transition issue, Regulation 23 specifies that a pilot ladder “shall be rigged through the trapdoor and extend to the height of the handrail” (V/23.3.3.2.1) and, in addition, “means shall be provided to secure the lower platform of the accommodation ladder to the ship’s side, so as to ensure that the lower end of the accommodation ladder and the lower platform are held firmly against the ship’s side.” (V/23.3.3.2). Similarly, Resolution A.1045 provides that when a trapdoor is used in a combination arrangement, “the pilot ladder should extend above the lower platform to the height of the handrail and remain in alignment with and against the ship’s side.” (A.1045, paragraph 3.8).

- a. pilot ladder rigged through the trapdoor extending above the platform to the height of the handrail;
- b. lower platform of accommodation ladder secured to the ship's side, so as to ensure that the lower end of the accommodation and the lower platform are held firmly against the ship's side; and
- c. pilot ladder remains against the ship's side.
