USCG MARINE SAFETY ALERT: MAINTAINING MACHINERY SUCTION

Safety Alert 04-18

Compliance with SOLAS and USCG Regulations for Operation of Main Propulsion and Essential Auxiliary Machinery Lessons Learned from the S.S. EL FARO Casualty

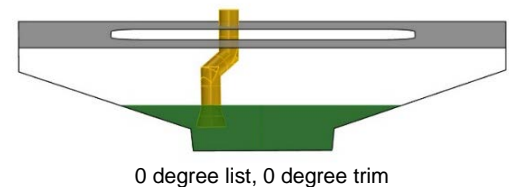
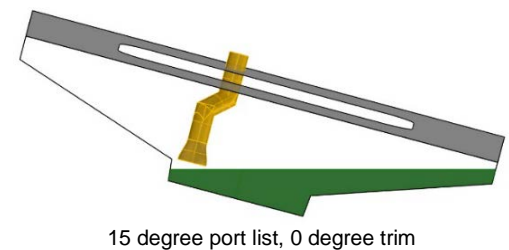
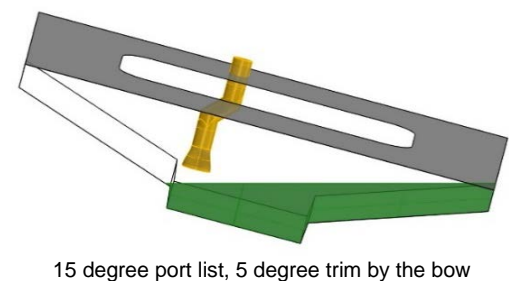
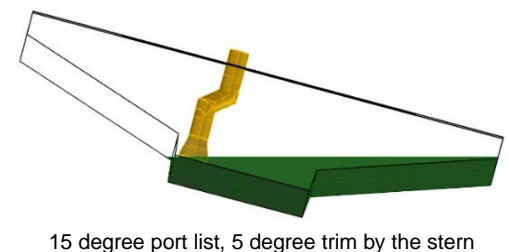
The Coast Guard Marine Board Report on the sinking of the EL FARO, with 33 lives lost, revealed that loss of propulsion during extremely heavy weather was a contributing factor to the sinking of the vessel. The exact operational status of all vital EL FARO engineering equipment during the hours preceding the casualty could not be determined. However, bridge audio recordings indicate that the vessel lost lube oil pressure to the main propulsion turbine and reduction gear bearings, resulting in loss of propulsion. It is believed that the vessel's substantial list, coupled with trim by the bow, caused the main engine lube oil pump to lose suction. A detailed modeling and static analysis of EL FARO's lube oil system determined that a severe inclination of the ship, coupled with a relatively low volume of oil in the sump, would likely result in a loss of pump suction. Figure 1 shows examples (at a constant lube oil volume) of the position of the suction bellmouth relative to the level of lube oil in the sump in several heel and trim conditions. This static model does not attempt to address the sloshing of lube oil in the sump caused by vessel motions.

Figure 1: EL FARO's main engine lubricating oil sump and off-center, aft oil suction bellmouth. Lubricating oil is shown in green. The pump's ability to maintain suction is affected by vessel list, trim, and motions, and the volume of oil in the sump.

- Operators verify that their main propulsion machinery, essential auxiliary systems, and emergency generators are designed in compliance with the CFR, SOLAS and Classification Society requirements for operation in static and dynamic conditions of list and trim.
- Engineering Department personnel review the design, arrangement, limiting angles of inclination, normal and limiting high/low lubricating oil sump levels, and casualty control procedures for all systems vital to the propulsion and safety of the vessel to better understand the possible ways to mitigate the effects of heavy weather on vessel operations.
