MEMBER ALERT

AUGUST 15, 2022

HIGH RISK FOR COLLISION WITH FISHING VESSELS IN FUJIAN WATERS

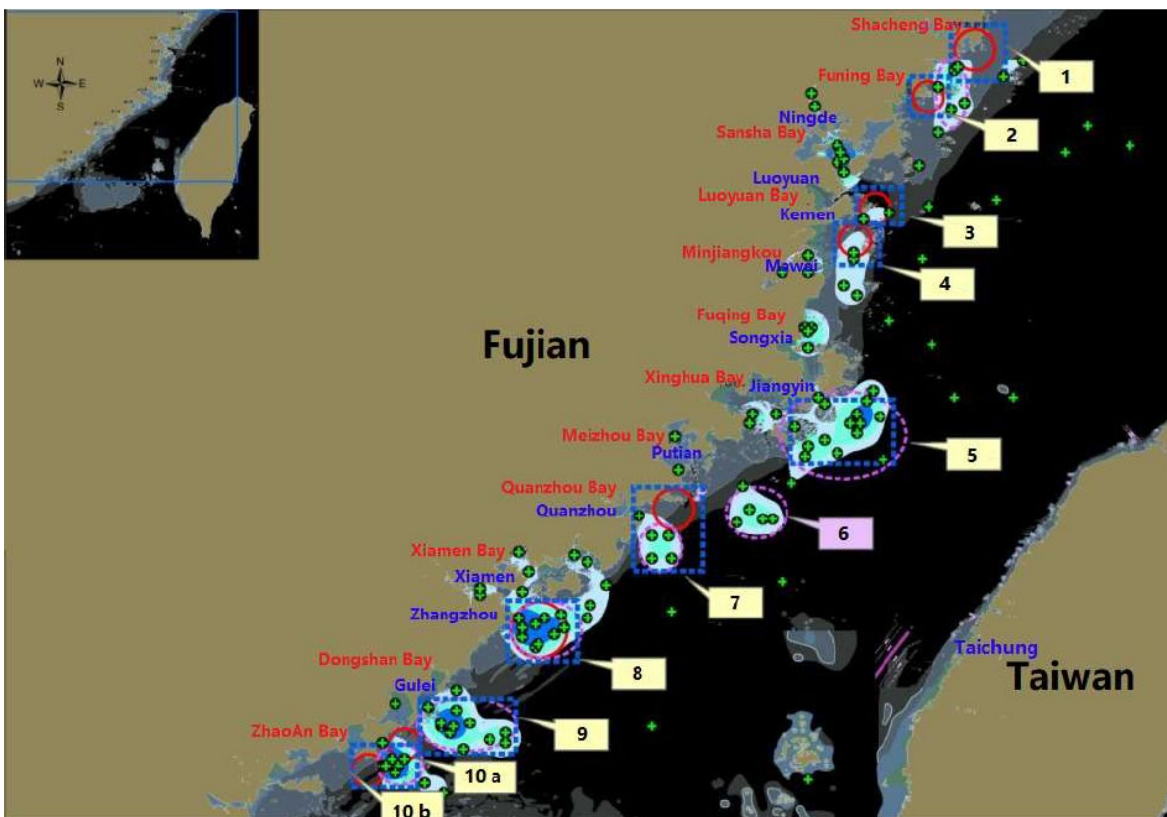
The Fujian MSA and FOFB have identified ten particular coastal areas as “high risk warning areas” based upon AIS tracking data and the analysis of collisions between commercial ships and fishing vessels over the prior ten years as illustrated in the picture below.

The coordinates for these ‘high risk warning areas’ as shown above are as follows:

- Ensure that vessel crews are familiar with the [Safety Guidelines for Preventing Collision Between Merchant Ships and Fishing Boats in Chinese Coastal Waters](#).

- Review and conduct any relevant safety training related to safety of navigation for fishing areas and collision avoidance procedures fishing vessels.

- Avoid traditional fish farms and fishing areas when voyage planning. Recommended routes should be carefully considered and strictly obeyed during transit through these areas.

- Effective radio communication in fishing areas can be a significant challenge given the number of fishing vessels and language differences. All available means should be considered and applied to warn fishing boats to prevent collisions.

- In the event of a collision with a fishing vessel, rescue operations should be performed immediately taking into account the safety of both vessels, their crews and the surrounding vessel traffic. Vessels should also immediately contact the Fujian MSA or VTS authorities or emergency phone telephone number at +86 12395.
