# MEMBER ALERT

**JULY 11, 2024**

## THE PEOPLE'S REPUBLIC OF CHINA (PRC): GUSHAN ANCHORAGE AT GUANGZHOU

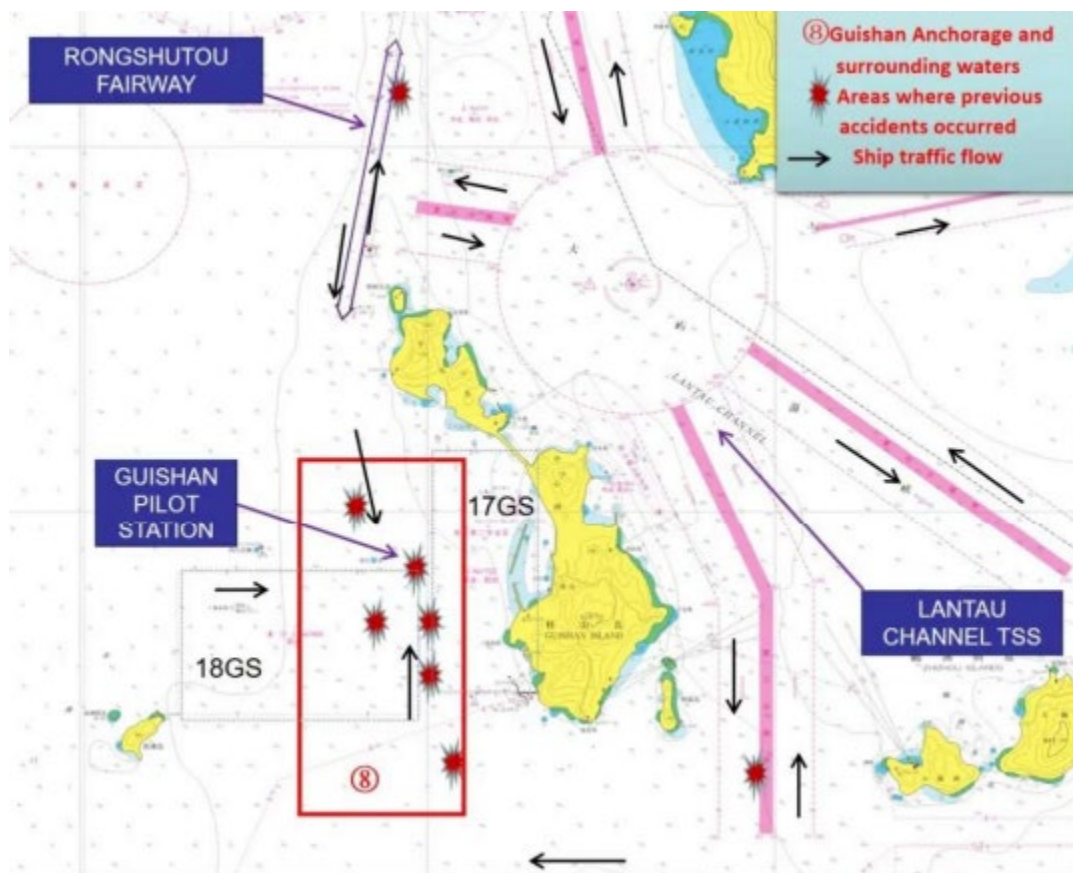
As the flood and typhoon season approaches in the PRC, currents and winds are expected to intensify at the Guishan anchorage and surrounding waters of the Pearl River Estuary. As shown in the diagram below, the area has recently seen an increased number of vessel collisions.

The Guishan anchorage and its surrounding waters are a convergence area for vessels navigating the Pearl River Estuary. Many vessels anchor at the 18GS anchorage area before entering port and many fishing vessels anchor at the 17GS anchorage resulting in limited vessel-handling maneuvering space in both areas.

The waters between the 18GS and 17GS anchorages are a customary route for inbound and outbound vessel traffic as well as a boarding and disembarking area for marine pilots. Vessels maneuver regularly in this heavy traffic area. The risks are compounded by possible miscommunications due to language barriers between vessels' crews. Furthermore, vessel traffic flow is complicated by vessels often crossing the area.

1. Vessels should avoid making large turns, accelerations and decelerations in the area.
2. Members are recommended to enhance the maintenance of vessels' mechanical and electrical equipment and proceed at a safe speed as necessary. When anchoring, vessels should maintain additional lookouts as well as ensure engine readiness and preparedness in case of an emergency.

3. Vessels should ensure the display of appropriate navigational lights and shapes as regulations require and engage additional watch personnel on the bridge. Short range radar scanning and VHF communication should be employed to maintain contact with other vessels as necessary.

4. Vessels should maintain constant communication with the pilot station and be well prepared to embark and disembark pilots given the limited maneuverability to avoid collisions.
