Fix it before the fall!

Consider the risks of falling from heights below deck.

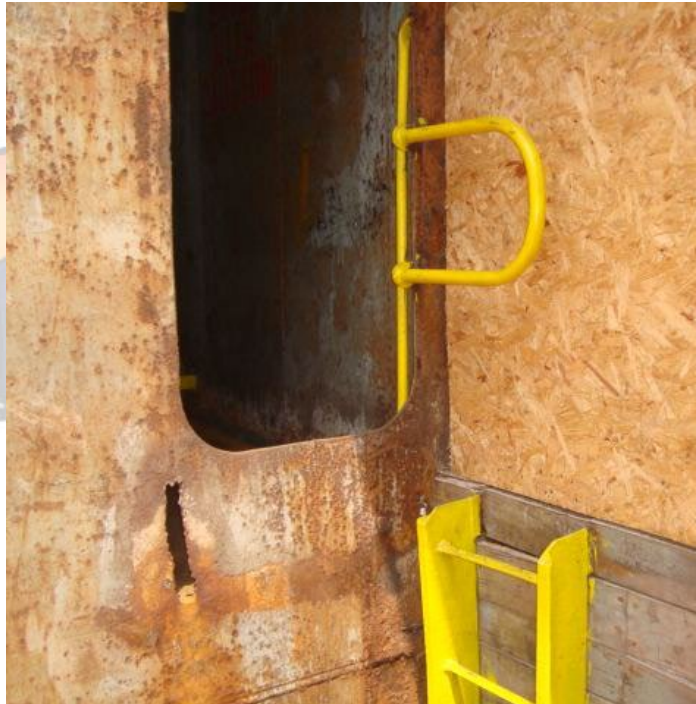
This incident resulted from the stevedore having grasped a weakened wooden batten board at the top of the ladderwell that broke while trying to climb off of the ladder. At the time of the incident, the ladderwell configuration offered no better option to hold onto at the top of the ladder.

A few months later, a similar incident transpired. In this instance, a 54 year old stevedore descended into cargo hold no. 2 and fell from the fixed ladderwell platform. As in the prior incident, it was discovered that the ladderwell hold design and configuration did not provide sufficient hand holds at the top of the ladder to prevent his falling. Eventually, modifications were made in order to ensure that grip bars above the ladder were installed above the ladder as seen in the figure.

- *The crew should inspect cargo hold access areas prior to cargo operations and only present the vessel in a condition that stevedores can load and discharge the cargo with reasonable safety.* Ladder's standing platforms, grip bars, rungs/treads, railings are free of dust, cargo debris, oily or greasy surfaces or any other condition that can cause a slippery condition.
- *Any latent hazards discovered by the crew are best corrected and repaired prior to commencement of cargo operations.* If any of the ladder's standing platforms, grip bars, rungs/treads, railings, etc. are in disrepair, do not use the ladder until it is fully repaired.
