# GOOD CATCH from **The American Club**

## Hand Injury & Hatch

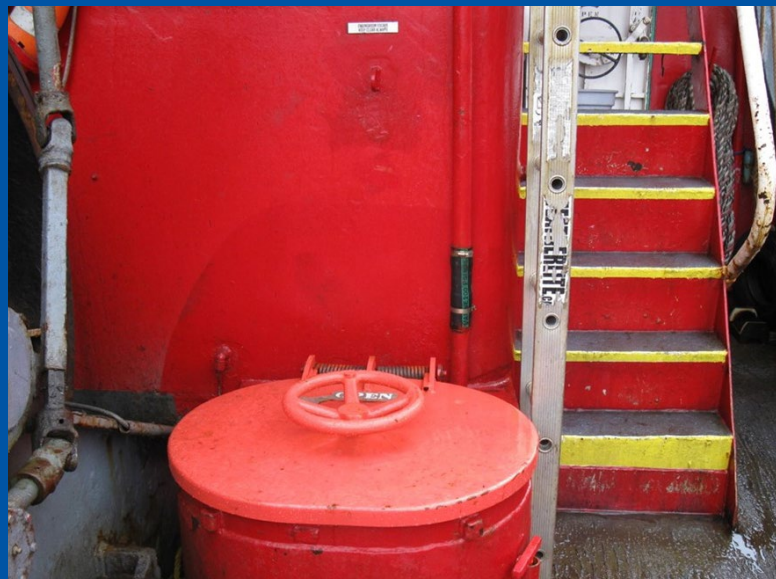
One of the deckhands decided to close the open hatch cover to the engine room emergency escape. He released the safety catch and started to lower the hatch. He saw that the hatch cover had a spring counterbalance and assumed that he may have to lean on the hatch cover to get it closed all the way. Instead, the heavy hatch slammed rapidly and unexpectedly closed and caught his hand. He screamed in pain but was able to lift the hatch enough to release his hand. It was immediately obvious that he had seriously injured it. It immediately started to swell and discolor, and he could not move his fingers. The injured deckhand was quickly sent to the emergency room for medical treatment.

The investigation found that the spring counterbalance was inoperative and was on the worklist to be fixed during the next shipyard period. The engineers on the vessel were aware that the spring counterbalance did not work. They had reported it to the vessel superintendent who had added it to the shipyard worklist. It took 2 of the engineers to open it, but the fresh air was welcome. They had planned to close it carefully before they vessel got underway, but the deckhand beat them to it. The deckhand was not aware that the counterbalance was not functional.

- ★ Mariners should exercise care with emergency escape hatch covers to ensure that hold-open devices, safety catches, and counterbalances function properly and have not corroded or been damaged.
- ★ The failure or inoperability of any equipment associated with emergency escape or emergency response should be immediately addressed. Repair should not be delayed until a future repair period.
- ★ Even the temporary inoperability of emergency equipment or emergency escape hatches should be clearly communicated to the entire crew. Further, steps should be taken immediately to address the increased risk from the malfunctioning equipment.
