GOOD CATCH from **The American Club**

Steel-Eating Insects Found on Vessels!

(Hatch Cover Corrosion)

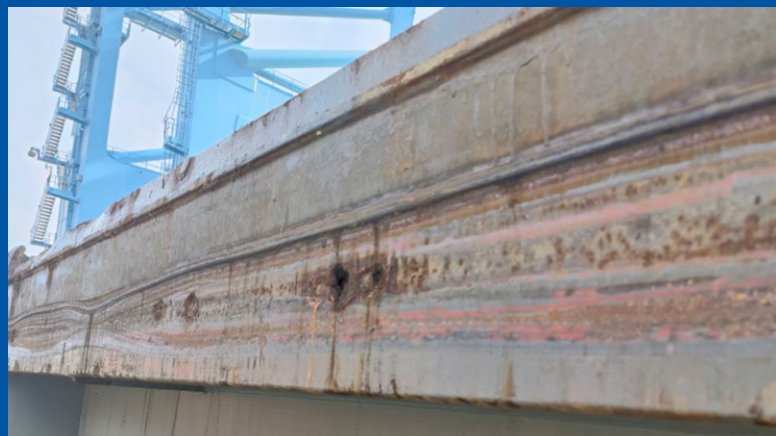
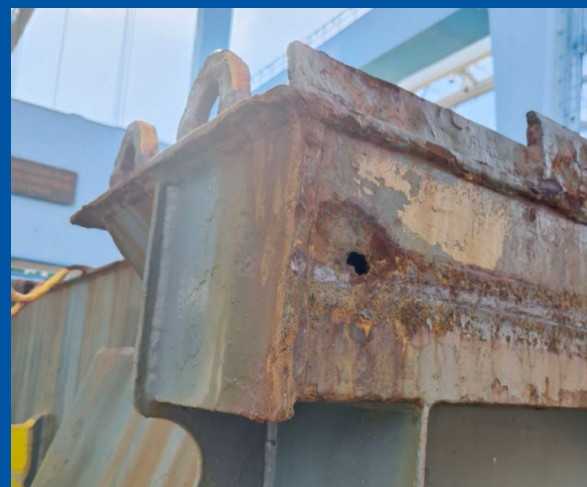
But corrosion and wastage on hatch covers is a real problem. A vessel carrying containers had several holes in their hatch covers due to corrosion. When the vessel arrived, they discovered that one cargo hold had 12-14 inches (30-35 cm) of water at the aft end of the hold. Sixteen containers had water ingress. The cargo was not damaged in 4 of the containers, but in the other 12 containers, the cargo was a total loss. Several of those containers were loaded with consumer electronics. Several others had automotive spare parts. One had designer leather shoes.

On investigation, the crew did not conduct daily inspections of the cargo hold bilges and had overly relied on bilge level alarms. Unfortunately, the bilge level alarm in this hold failed when the float switch had become stuck. The vessel had no records of hatch cover inspections or preventive maintenance on the hatch covers.

The water ingress into the cargo holds was worse than experienced on previous voyages. The vessel had encountered several days of heavy rain and high seas during their transit. But it was also raining heavily while the containers were being loaded. Thus, the source of the water could not be positively determined but it was likely from a combination of both sources.

- ★ Are hatch covers inspected periodically for signs of wear, or corrosion, or damage?
- ★ What should you do when you see a hatch cover with a structural or corrosion problem?
- ★ What is your common practice for checking proper operation of cargo hold bilge alarms?
- ★ What is your common practice for checking the cargo hold bilges prior to departure and while underway?
