GOOD CATCH from **The American Club**

The Right Image

FIRE SAFETY

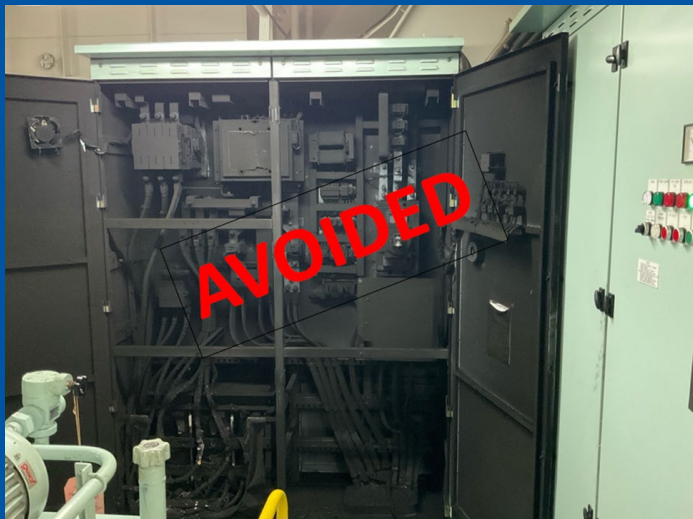
They identified one electrical connection with a dangerously high temperature due to excessive soot buildup on a breaker. After thoroughly cleaning the soot, they rechecked the area using a thermal imaging camera, confirming that the temperatures had returned to safe levels.
