Workload Distraction Results in a Grounding

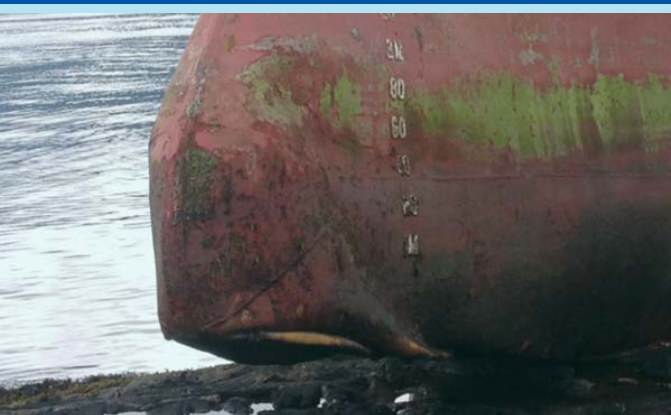
The investigation revealed that the Second Officer was significantly distracted from his primary watchstanding duties when he was working on the passage plan and updating the paper charts. These workload distractions caused him to initially miss a planned turn and later to incorrectly plot a fix on the chart. While that fix had been correctly taken and recorded in the log, he had incorrectly plotted it on the chart. Had it been correctly plotted, the Second Officer would have seen that the vessel was significantly off the intended track line and was at risk of grounding.

The vessel remained hard aground for several hours until refloated by the rising tide. It was taken out of service and proceeded directly to a shipyard for a detailed damage assessment and repairs. Fortunately, there were no injuries to the crew or pollution.

- ★ Crews should be reminded that the primary responsibility of the Officer of the Watch is the safe navigation of the vessel.
- ★ The watch relief process is critically important. The oncoming Officer of the Watch needs to know and verify the vessel's location, course and speed. But he or she also needs to identify potential hazards the vessel will likely encounter during that watch before assuming the watch.

- ★ Distractions while on watch should be eliminated or minimized to the maximum extent possible. Those distractions can include other legitimate work such as updating charts, checking emails, catching up on other log entries, passage planning, etc. While all legitimate work, they should not be done while on watch.

- ★ Passage plans should be developed, reviewed and approved in advance of departure. Additionally, they should be presented for review as a complete berth-to-berth plan so each portion of the voyage can be reviewed in context with the other portions.
