Using Inadequate Bollards

GOOD CATCH

January 2022

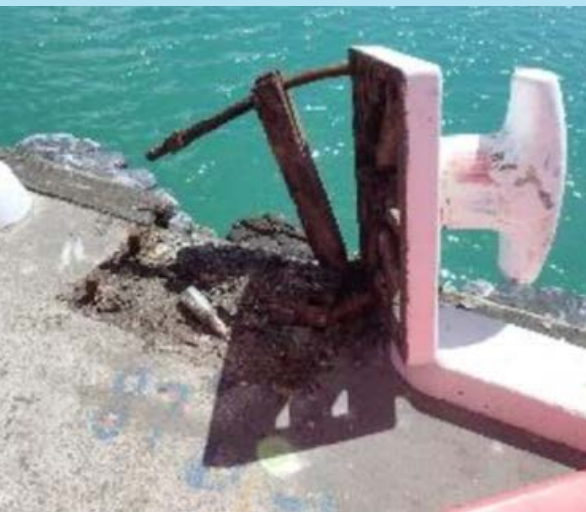
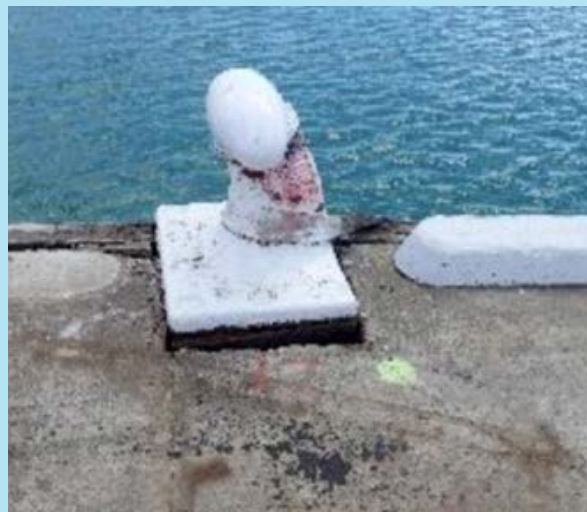
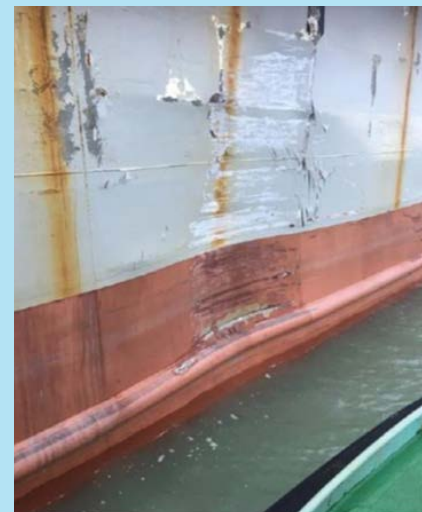
- Several bollards failed because of the insufficient way they were fastened to the wharf.
- Other bollards failed because of the inadequate dock structure under the bollards.

- All of the bollards that failed did so well below the breaking strength of the mooring lines and vessel's mooring system.
- The port did not know the actual safe working loads of the various bollards.
