GOOD CATCH from **The American Club**

26th Layer of Paint Eliminates the Need for Bolts (Preventative Maintenance)

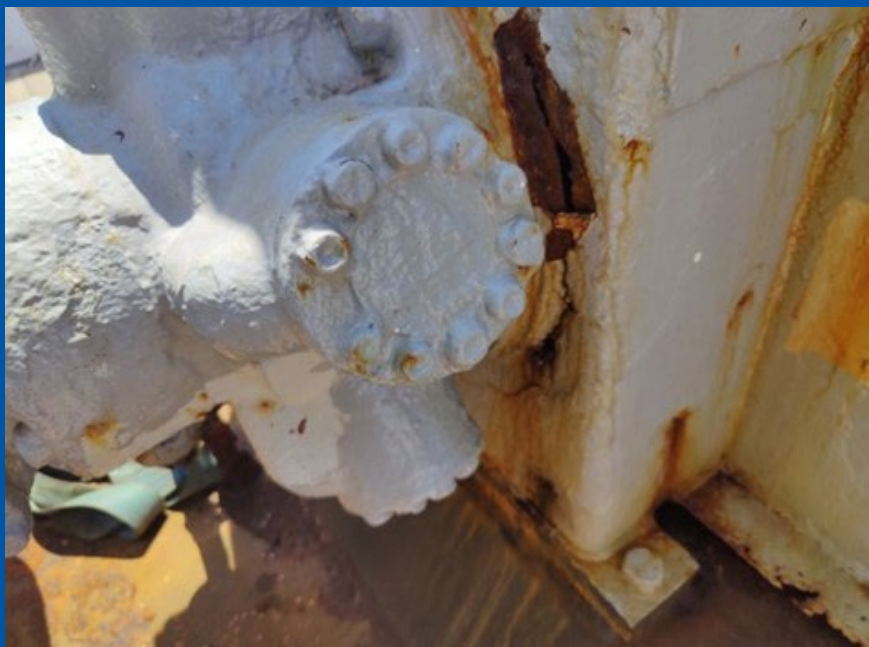
The crew on a general cargo vessel identified that the portside anchor winch was making an unusual noise while the anchor was being raised. An investigation by the engineers discovered that the corrosion between the anchor winch motor mount and the winch housing was so excessive that the motor pinion gear was out of alignment with the gear on the anchor winch. That gear misalignment was the source of the unusual noise.

The vessel operator arranged for a technical representative to visit the vessel. He confirmed that the motor pinion gear had been damaged from the misalignment, but that the anchor winch gear was still in good condition. He noted that repairs would also be required on the housing to rebuild the mount for the motor. He observed that long-term corrosion around the motor mount had been covered in numerous layers of paint which did nothing to preserve the steel but temporarily hid the problem visually.

The motor pinion gear had to be replaced at a total cost of \$21,500. The additional cost to repair and rebuild the housing and motor mount was \$4,500.

- ★ Does your preventive maintenance program for deck equipment such as anchor winches include an inspection for excessive corrosion?
- ★ What should you do if tasked with painting but find the surface to be painted not properly prepared and heavily corroded?
- ★ What should you do when you discover any area of steel wastage while painting?
