GOOD CATCH from **The American Club**

Keep the fire **INSIDE** the incinerator!

THERMAL SHOCK

November 2024

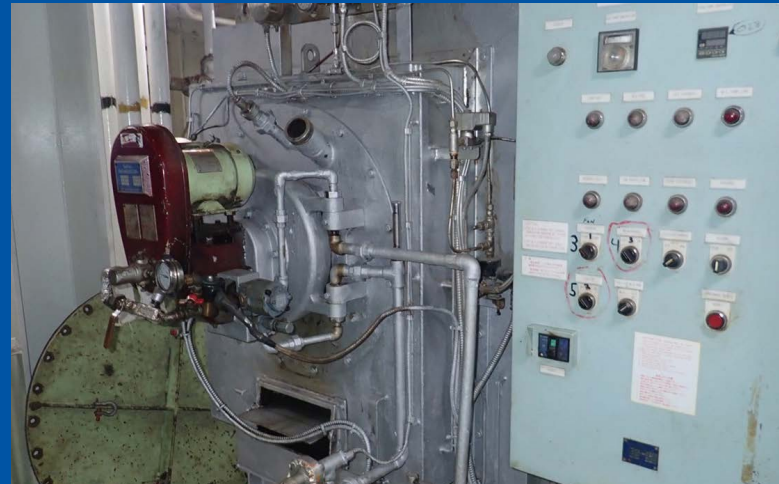
An investigation was conducted and the incinerator manufacturer's representative found that the refractory brick was severely cracked. He noted that this type of cracking was due to temperature shock usually associated with cold water contacting the refractory brick while it is hot. The crew admitted that they had on occasion added water to the sludge tank while the incinerator was being operated but were unaware that could result in such damage to the refractory bricks. The added water was intended to make the sludge flow more easily and prevent clogs that will cause the incinerator to shut down. However, when added while the incinerator is running, a slug of cold water can create a temperature shock to the refractory brick and cause it to crack.

The cracks in the refractory brick allowed excessive heat to escape from the incinerator which caused oil-soaked insulation on the nearby waste oil tank to smolder and eventually ignite.

- ★ Does your training emphasize safe operation of the incinerator and include awareness and precautions to prevent thermal shock to the refractory brick?
- ★ Is your crew reminded not to add water to the sludge tank when burning sludge to avoid thermal shock to the refractory brick?
- ★ Is the refractory brick regularly inspected and repaired as needed to ensure it is in good condition?
- ★ Are regular inspections and tests of the incinerator automation and safety devices conducted?
