## GOOD CATCH from The American Club

# Knowing the Barge Condition **BEFORE** Starting the Tow

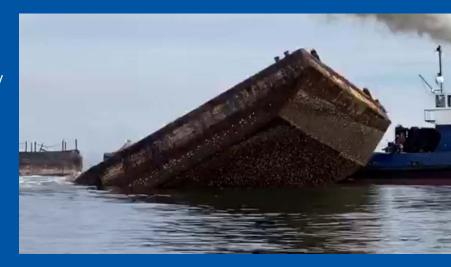
The towing vessel crew verified that the crane was secure to the deck and that other associated gear was adequately strapped down. They noted that one of the oval-shaped hatch covers was missing. Another hatch cover at the bow rake was partly open and there was a hose leading down into the rake. They

removed the hose but could not find additional nuts to properly secure the hatch cover. Instead, they put the hatch cover in position and finger-tightened the one nut that was there. They also noted that the barge had seen better days and had a lot of corrosion and numerous indentations on the main deck, the bow, and the sides.

- **★** Did the crew adequately assess the condition of the barge before getting underway?
- ★ Were the issues with the hatch covers and the poor overall condition of the barge properly assessed?
- ★ Was there a reason a hose was rigged into one of the barge compartments? Was it there as a dewatering hose?
- ★ Could the barge's compartments have been inspected to see if they contained water?
- ★ Was the Master's haste to get underway a factor in deciding not to report the issues with the barge to the Port Captain?
