GOOD CATCH from **The American Club**

Mariners Forced to Walk the Plank

(Accommodation Ladder)

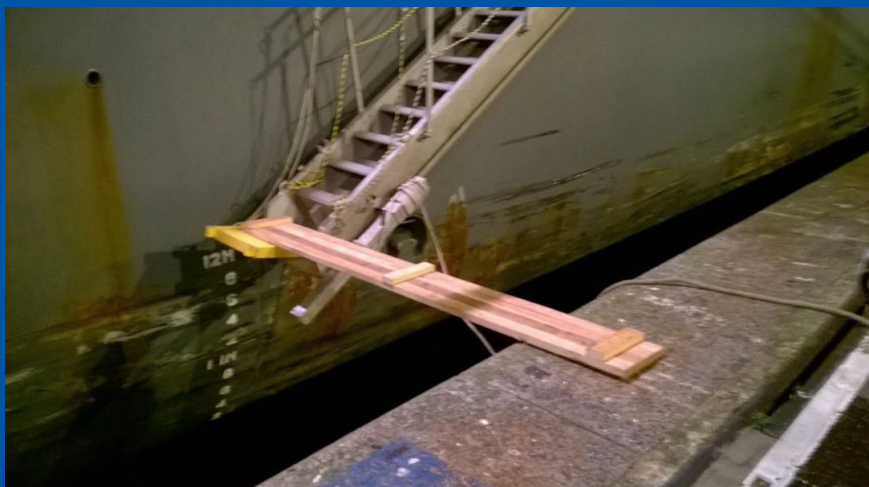
A general cargo vessel arrived at its terminal destination to load cargo and found that the vessel's accommodation ladder would not swing out to the dock. A wooden plank arrangement was rigged without any handrails and was put in place by the bosun with the full knowledge of the vessel's Master and Chief Officer. The pilot who helped bring the vessel into port refused to disembark using the wooden plank arrangement. Instead, he called for the pilot boat and disembarked the vessel using the pilot ladder on the other side of the vessel.

Believing it to be very dangerous, the pilot notified the local Port State Control authorities. Port State Control officers visited the vessel and immediately issued 2 deficiencies and detained the vessel due to non-compliance with their safety management system (SMS). They instructed the vessel to prohibit anyone from using that wooden plank arrangement and required them to rig a safer arrangement. The noted deficiencies were based on the unsafe embarkation arrangement, and the vessel not following their safety management system procedures regarding safe access. The Port State Control authorities required an audit of their SMS to be conducted prior to the vessel departing because they viewed this as a major nonconformity in the SMS because the embarkation arrangement was so dangerous.

No one was actually injured, and no one fell into the water, but this was an accident waiting to happen. The quick decision to prohibit the use of the wooden plank was a large factor in no one getting injured.
